**U.S. DEPARTMENT OF COMMERCE**  
National Oceanic and Atmospheric Admin.  
**NATIONAL OCEAN SERVICE**  
Florida Keys National Marine Sanctuary

**SUBJECT:** **MYRA LEE** Vessel Grounding Assessment

**DATE OF ASSESSMENT:** 12/11/00

**REPORT DATE:** 1/9/01

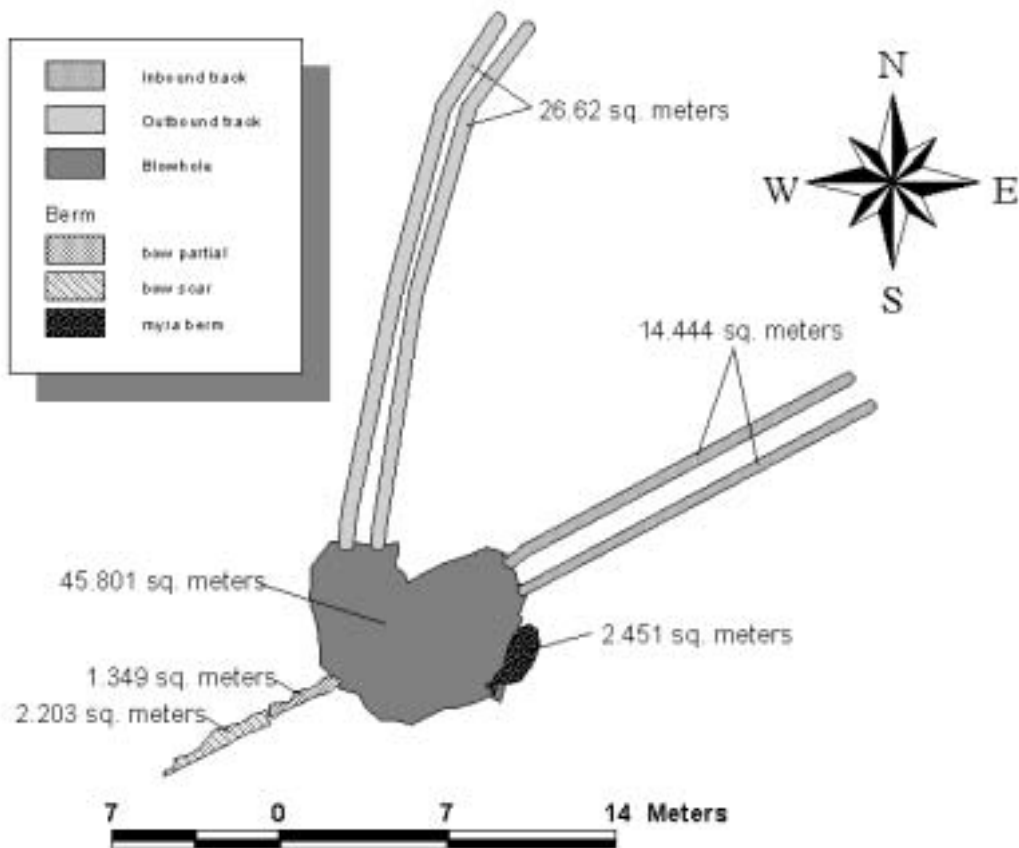
**FIGURE 1: “MYRA LEE” Vessel Grounding**

An injury assessment was conducted on December 11, 2000 by FKNMS Resource Manager Lauri MacLaughlin with NOAA/DAC field scientists Kevin Kirsch and Sean Meehan. This survey involved deploying a fiberglass measuring tape along the baseline of the grounding track and mapping the injury area based on length, width and depth dimensions. Compass headings were also recorded. A map of the grounding track is included in this report (see Figure 1).

The habitat throughout the area of the grounding site is characterized as a shallow seagrass bank inhabited by turtle grass, *Thalassia testudinum*, finger coral, *Porites* sp., manatee grass, *Syringodium filiforme*, the green calcareous alga, *Halimeda* sp., *Udotea* sp., *Caulerpa* sp., *Penicillus dumetosus*, miscellaneous marine algae and sponges. Below is a description of our observations, as they apply to the diagram in Figure 1.

The inbound track consists of twin propeller scars that extend 15.5 meters in length, in a southwesterly direction (243°-239°), and which terminate at a large blow hole. A small berm borders the east edge of the blow hole. The final resting place of the bow extends 7.69 meters southwest (235°) beyond the blow hole. The outbound track extends from the west end of the blow hole to the north (005°-010°) for a distance of 23.03 meters. The inbound tracks, blow hole and outbound track are characterized as total destruction to the seagrass bed. A portion of the final resting place and the berm are characterized as partial destruction.
